Subject: Critical Areas Report  
(Geotechnical Aspects)  
Gunshy Manor  
20005 NE Union Hill Road  
Redmond, Washington

Critical Areas Report  
(Geotechnical Aspects)

### **GUNSHY MANOR**

Project No. KE090291B  
April 5, 2012

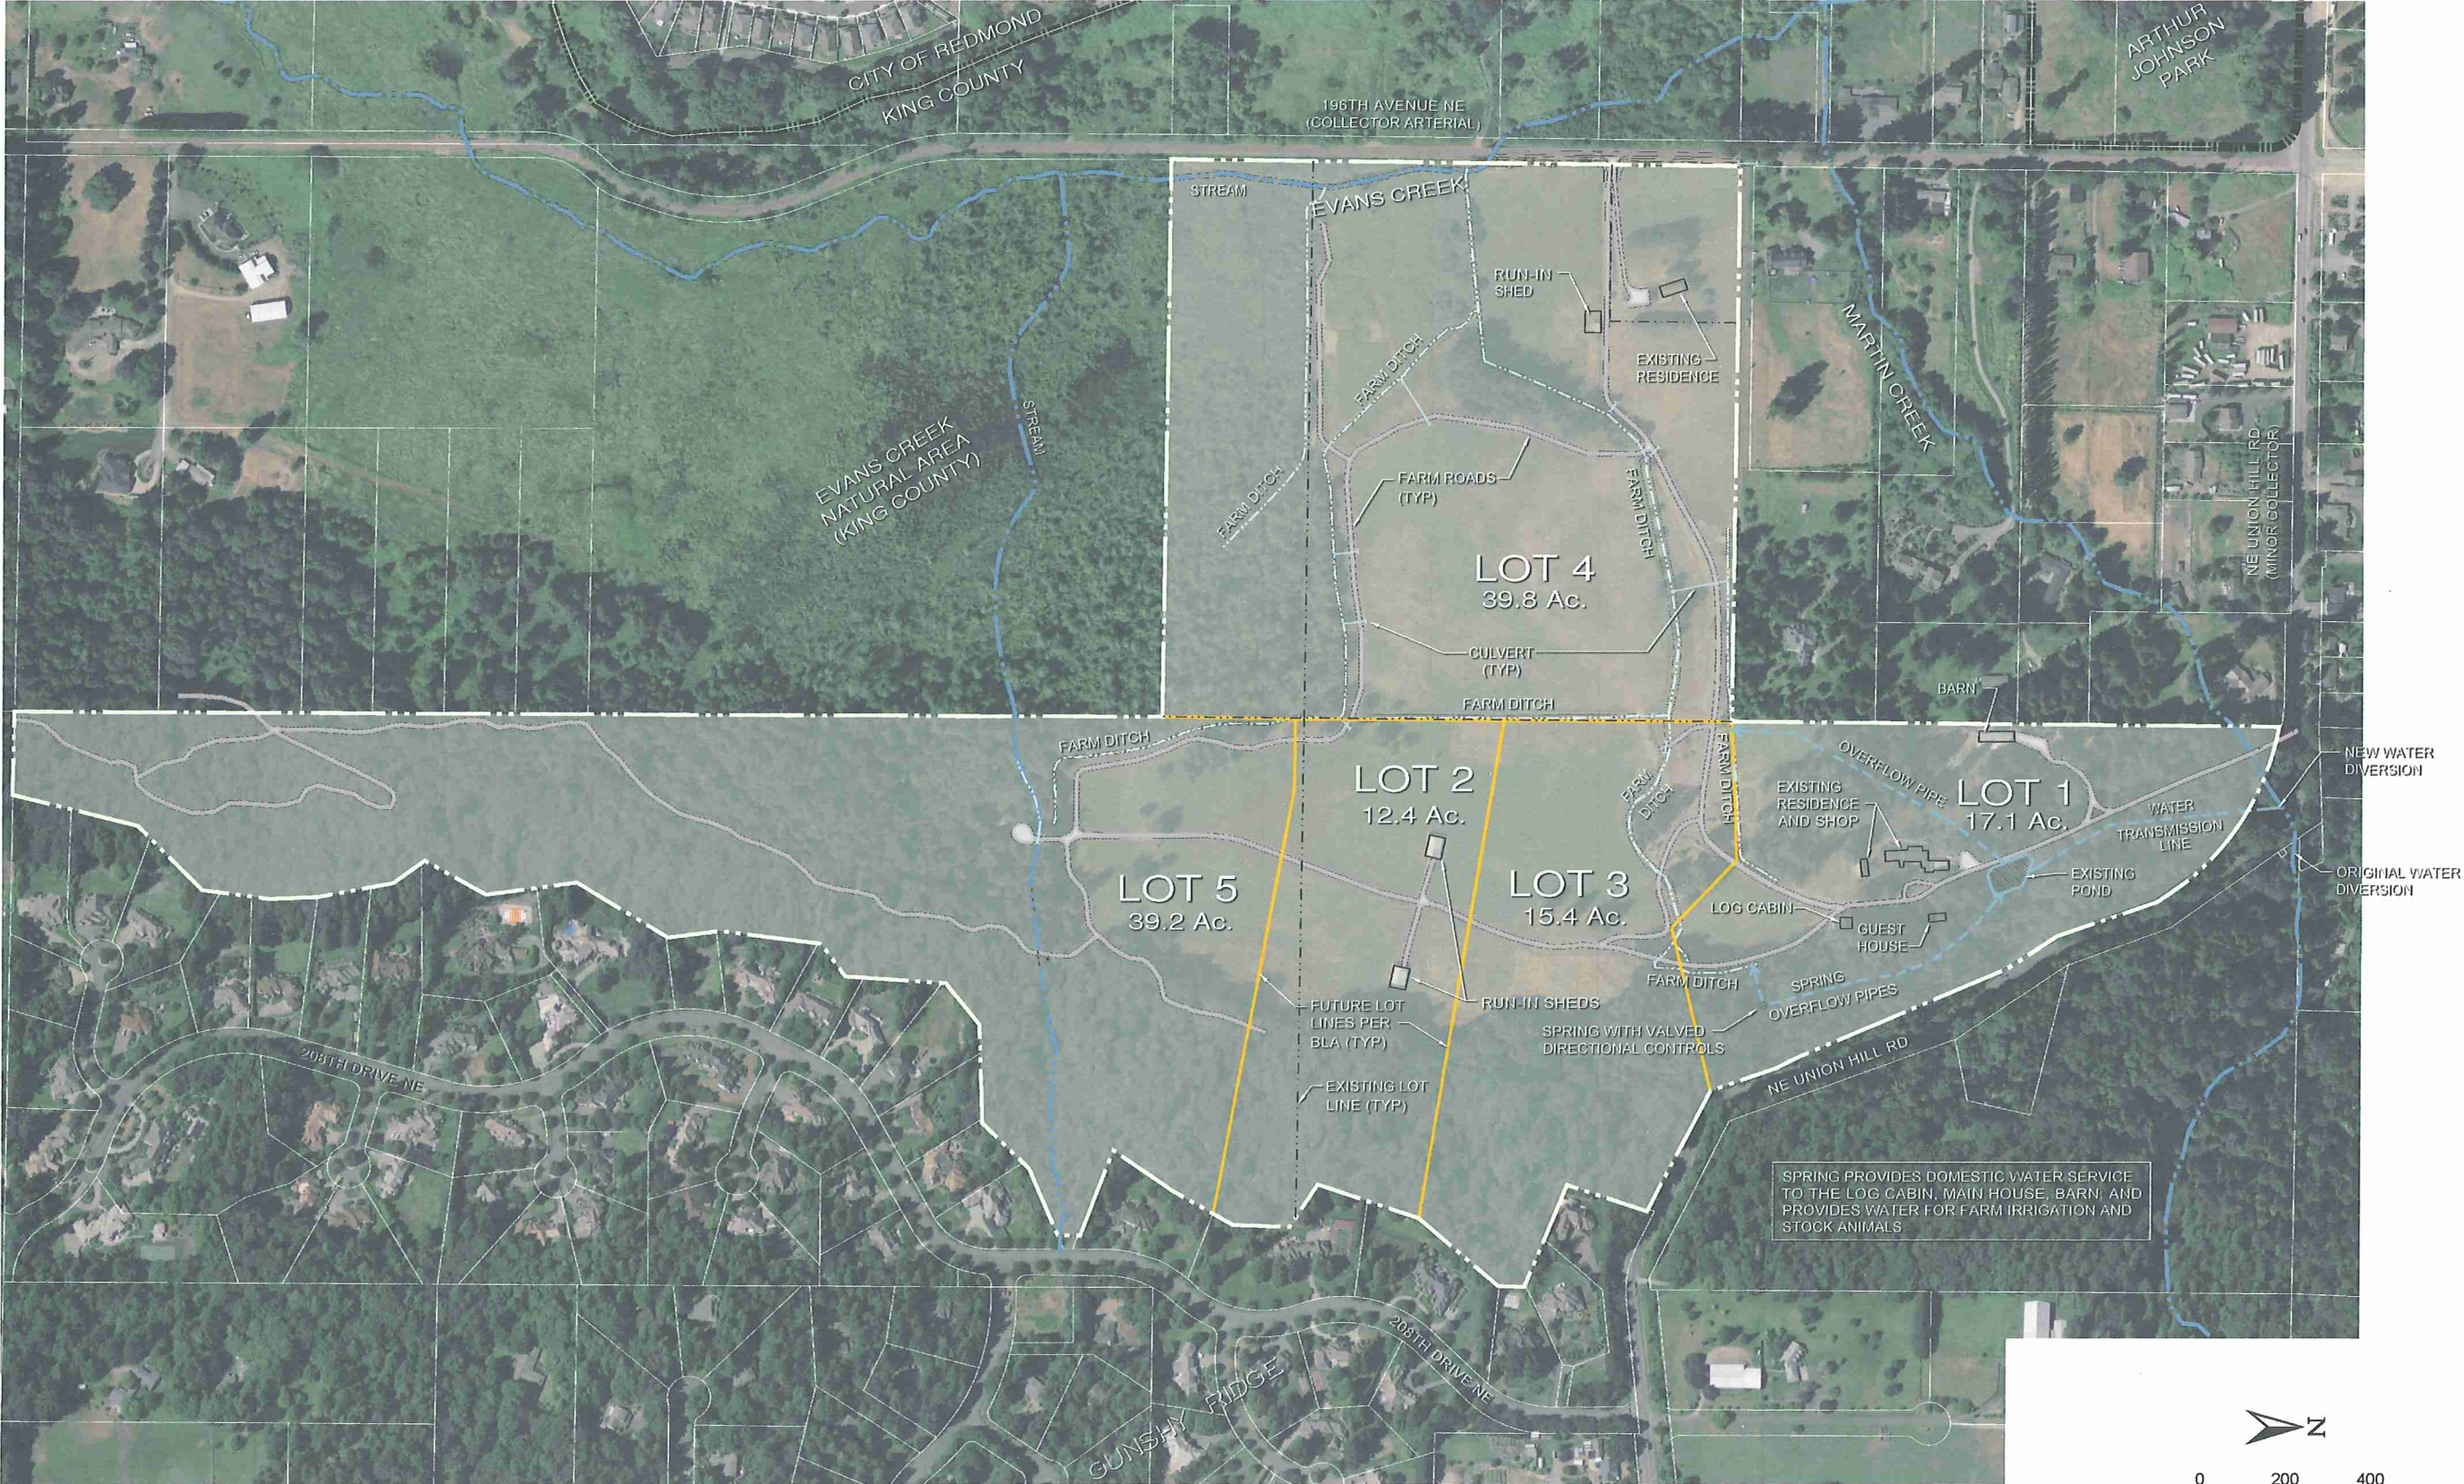
FIGURE 2  
DATE 3/12

SITE PLAN  
GUNSHY MANOR  
REDMOND, WASHINGTON

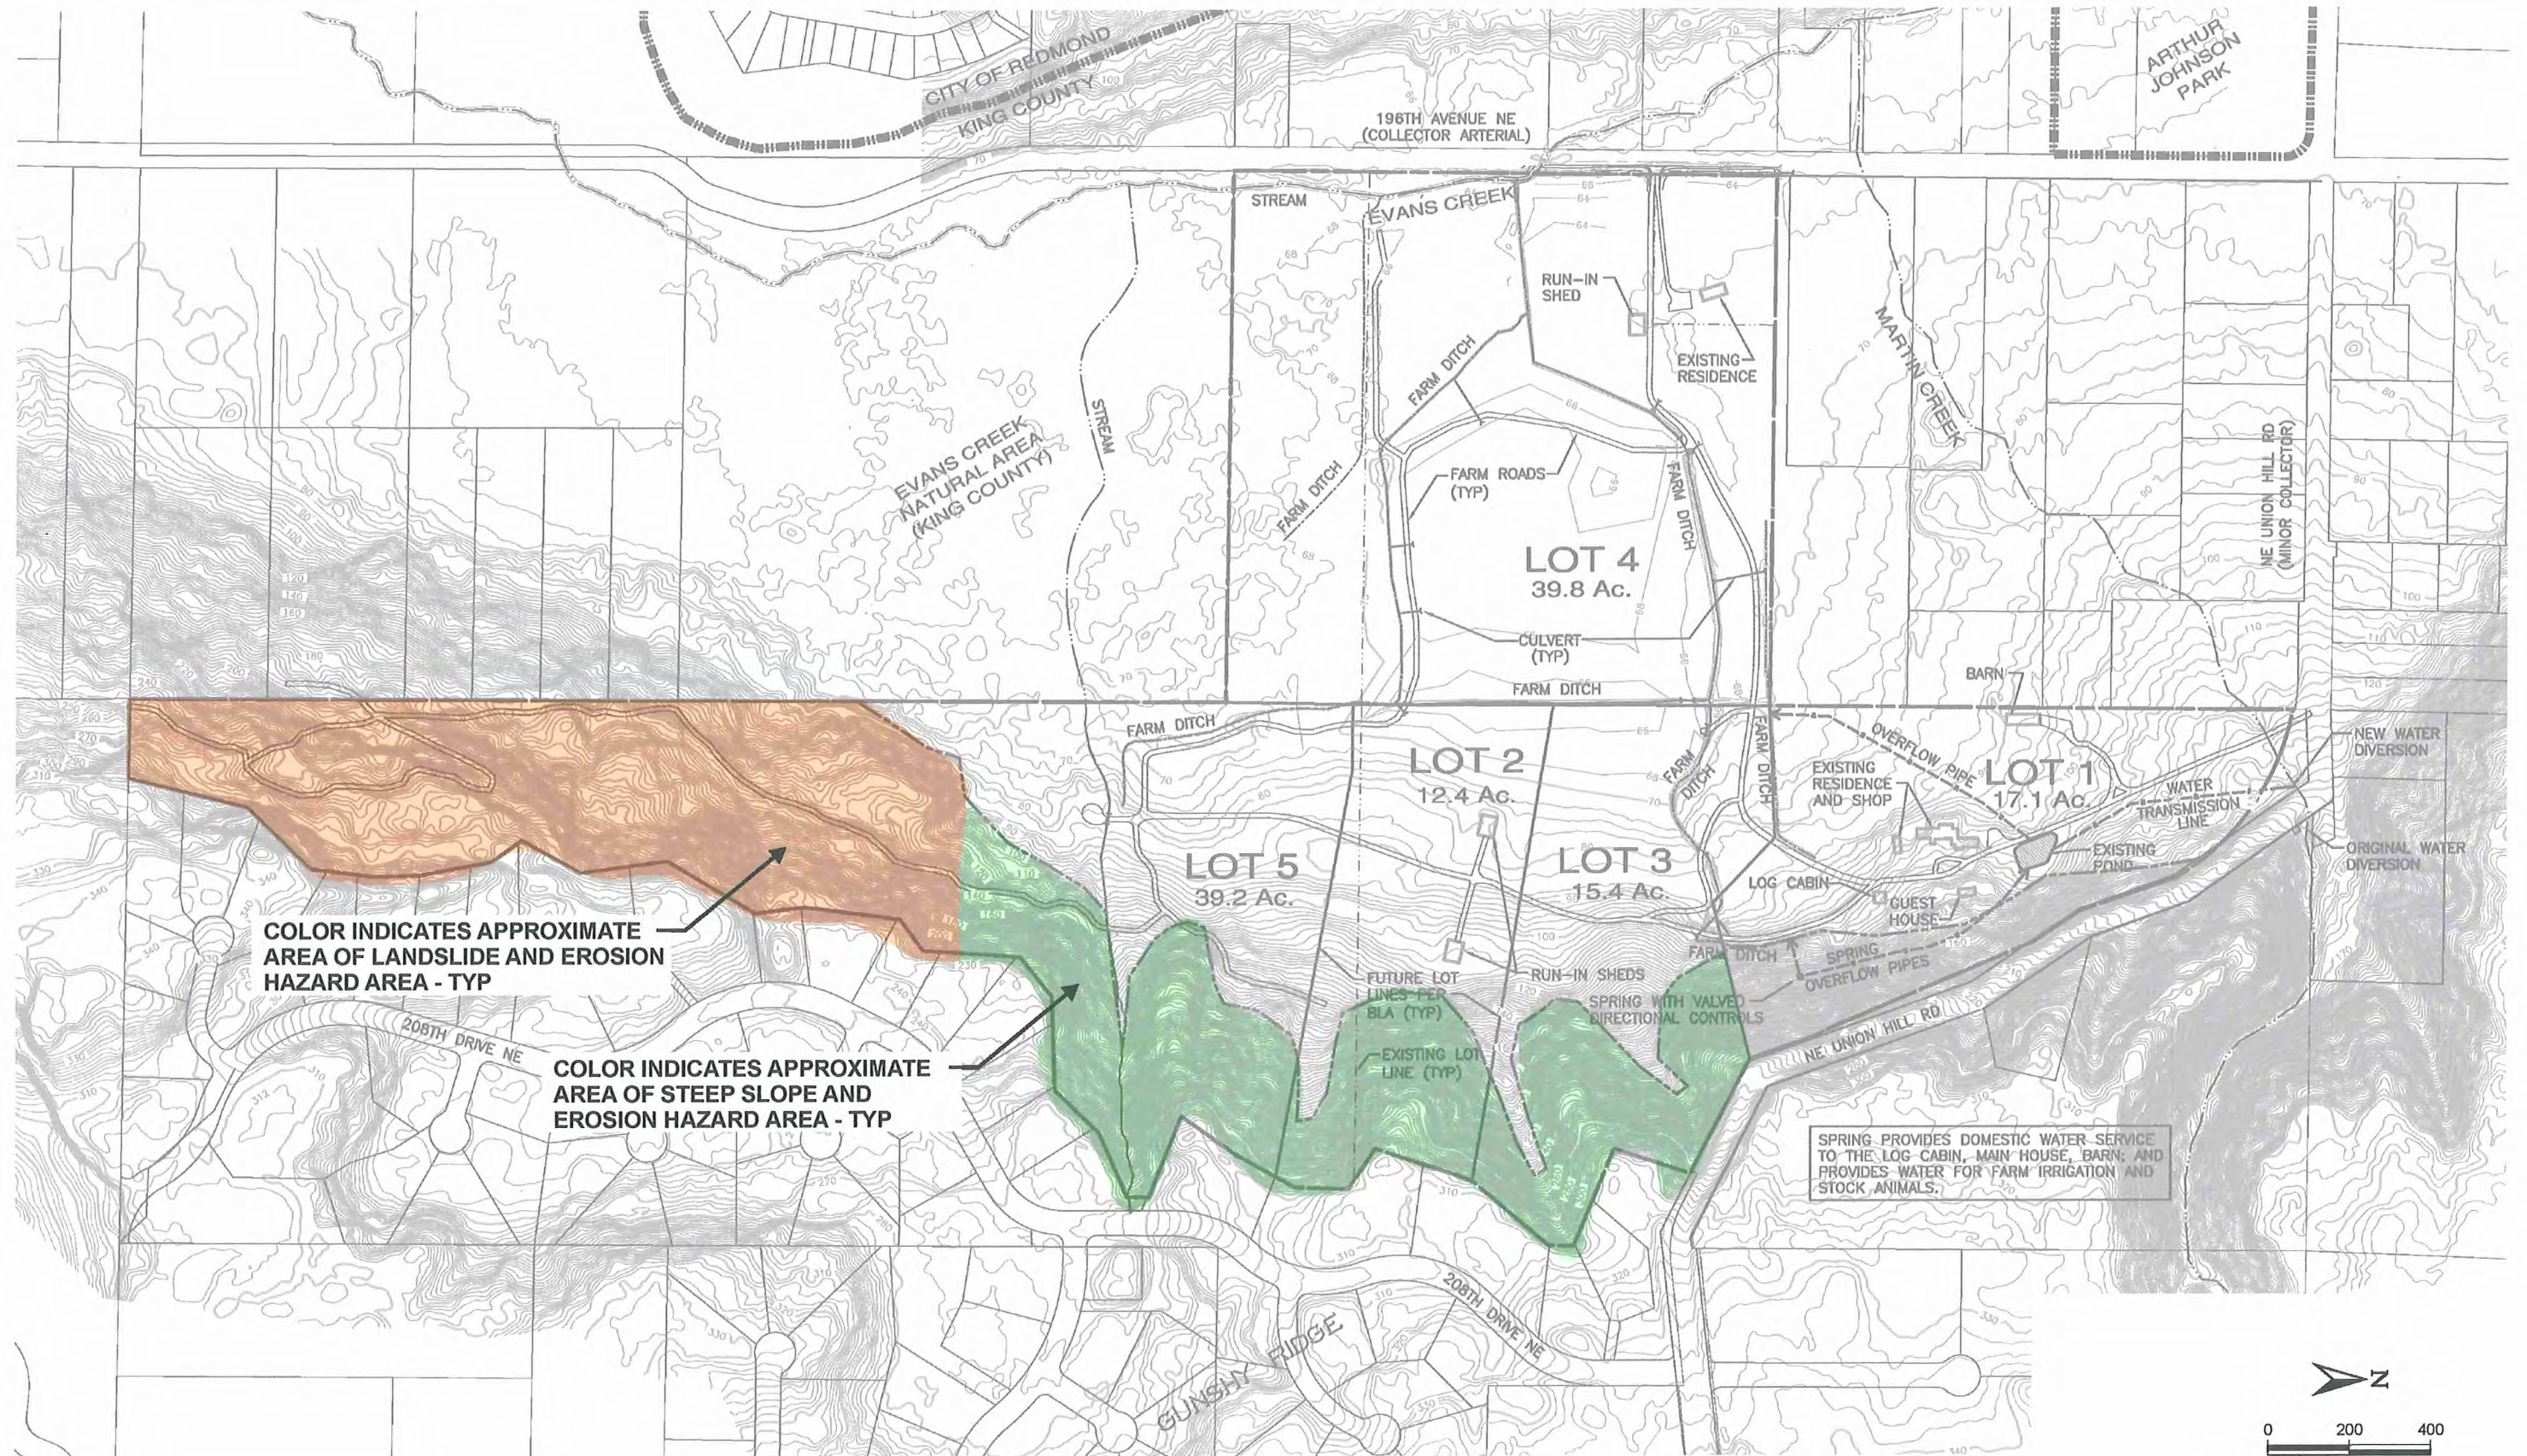
FIGURE 3

CRITICAL AREAS MAP - GEOLOGIC HAZARD AREAS  
GUNSHY MANOR  
REDMOND, WASHINGTON

Based on the KCC criteria and existing site conditions, areas of the site at the south end of Lot 5 are classified as Landslide Hazard Areas. The locations of the Landslide Hazard Areas are shown on Figure 3.

Section 21A.06.1230 defines Steep Slope Hazard Areas as an area on a slope of 40 percent inclination or more within a vertical elevation change of at least 10 feet. Inclinations of the steep slopes on the east parts of Lots 2, 3, and 5 range from 40 to 58 percent and are classified as Steep Slope Hazard Areas and are shown on Figure 3.
